ST. JOE STATE PARK DAM
ST. FRANCOIS COUNTY, MISSOURI
MO 30277

PHASE 1 INSPECTION REPORT NATIONAL DAM SAFETY PROGRAM

PREPARED BY: U. S. ARMY ENGINEER DISTRICT, ST. LOUIS

FEBRUARY 1980

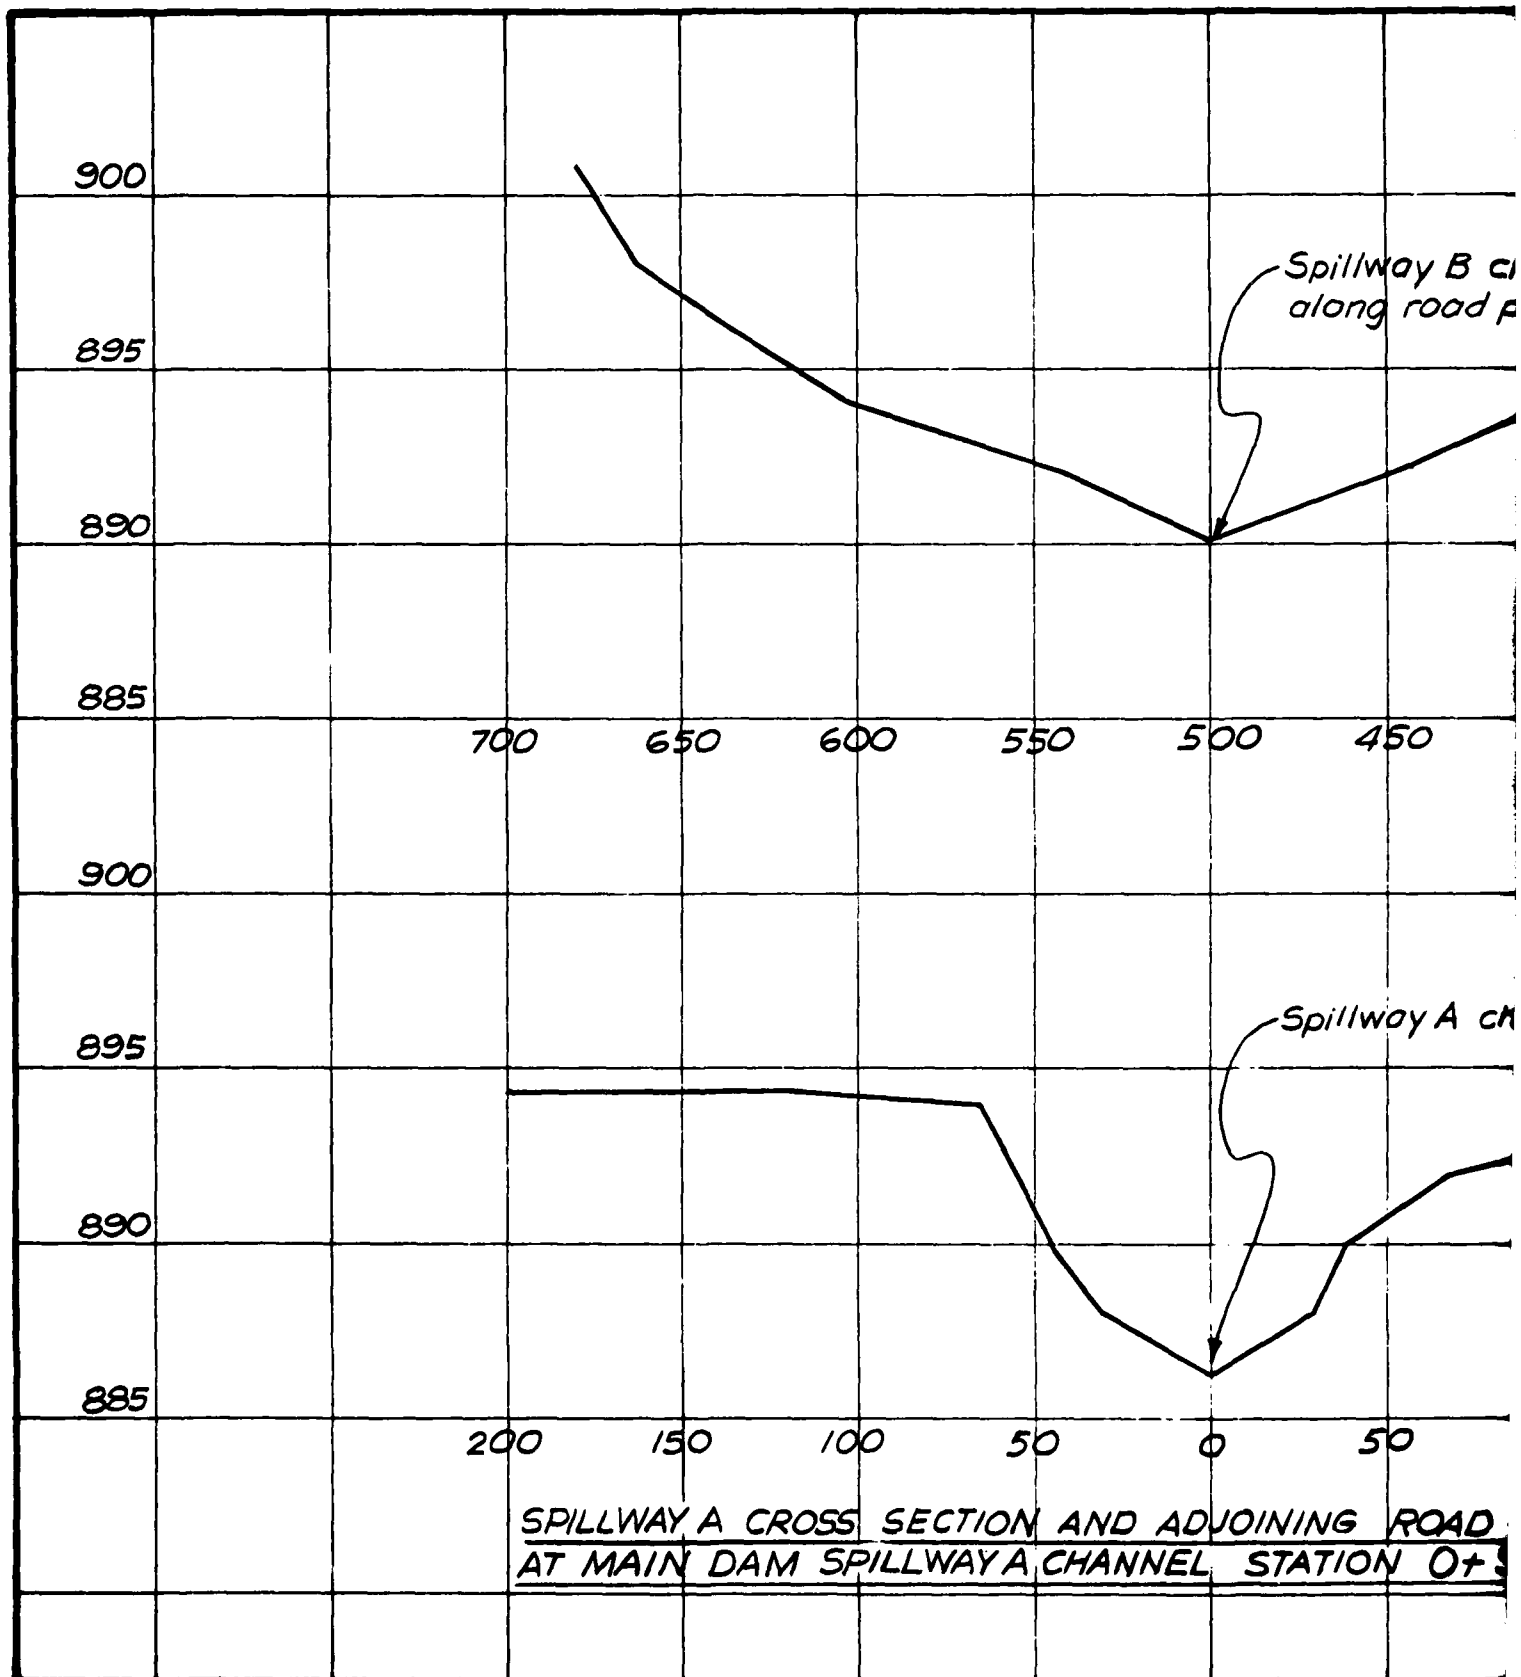
DATE
DRAWING NO.
PLATE 7A

Spillway B channel-Low point
along road profile
